**Oroville Facilities Relicensing Efforts
Draft Narrative Reports for Resource Action Discussion**

Resource Action: EWG - 31

Warm Water Species Habitat Enhancement in Lake Oroville

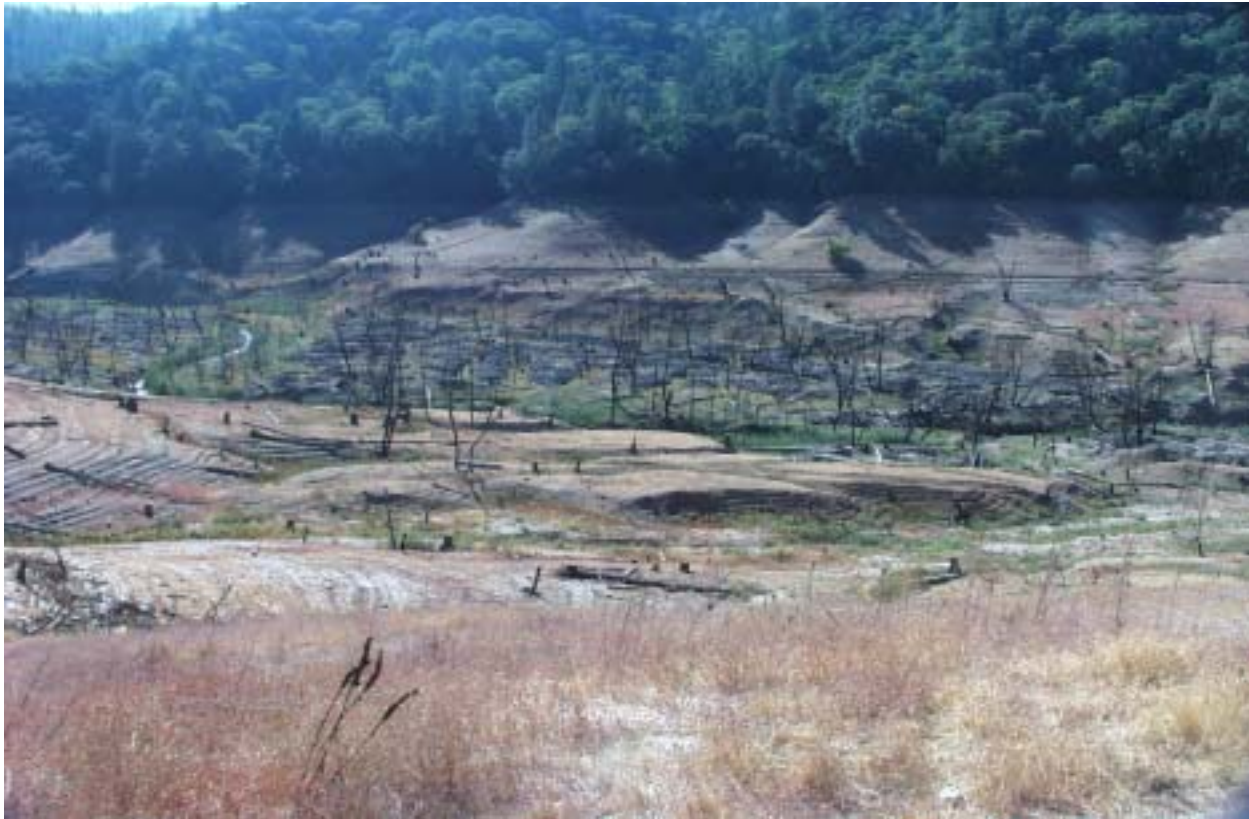
Figure 2 Vegetation Retention Area (McCabe Cove)

When Lake Oroville was constructed, the vegetation was removed from the hillsides that were to become inundated, except for selected areas referred to as "Vegetation Retention Areas" (Figure 2). In these areas, large woody debris such as trees and logs were left to provide macrocover for reservoir fisheries. Eighteen areas were designated totaling over 1100 acres. These areas have degraded over time, due to wood decaying processes, along with wave action, water fluctuations, and the rusting of many of the anchor cables used for the log structures.

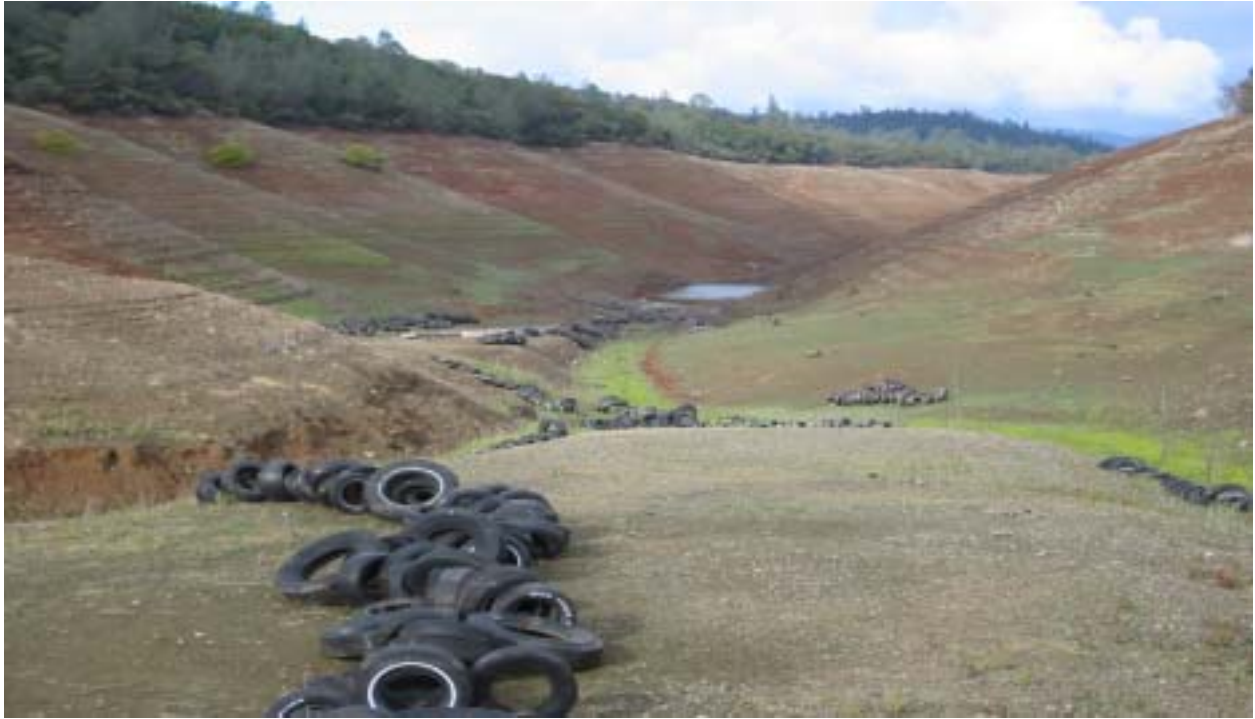
Figure 3. Tire Reefs (Miners Ranch Area)

During the 1980s, the Department of Fish and Game (DFG) and DPR, along with several fishing organizations, constructed reefs made of discarded tires in several coves around Lake Oroville (Figure 3). Although these reefs are an effective, durable, and inexpensive type of fish habitat, providing habitat for centrarchids as well as channel catfish, they also have a tendency to retain water when the lake recedes, which provides suitable habitat for mosquito breeding. DPR has requested that these reefs be replaced with fish habitat that will not create the same problem, such as large woody debris, brush shelters, and willow trees.

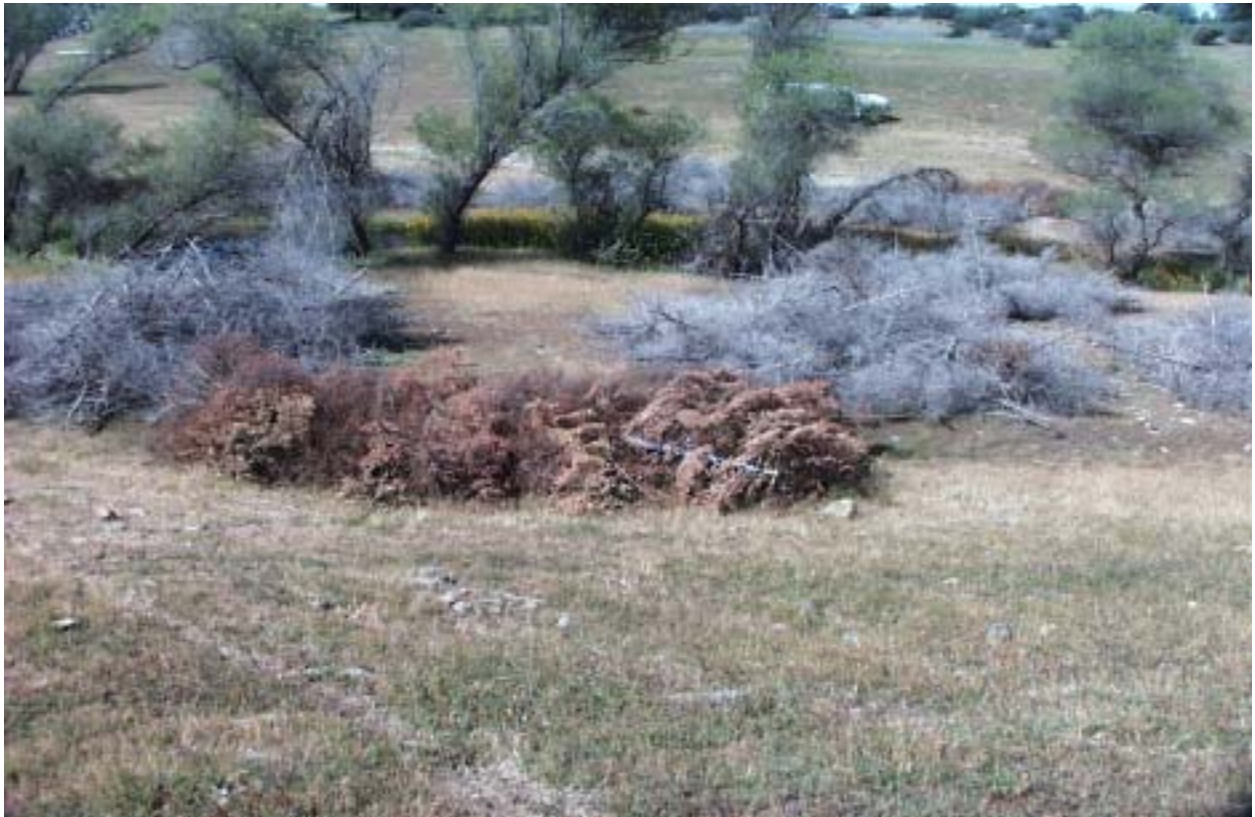
Figure 4. Christmas Tree Brush Shelters (Miners Ranch)

Brush shelters are reefs that are constructed on the lakebed within the reservoir fluctuation zone (Figures 4 and 5). They consist of various materials including discarded Christmas trees, trees/brush cut from the upland areas adjacent to/near Lake Oroville, and artificial habitat structures made of plastic. The brush shelters are anchored to the lakebed using steel fence posts, concrete blocks, or other suitable materials, to keep the brush shelters from floating away when inundated during the spring and summer. Typically brush shelters are built as separate units covering 150 to 400 ft² of lakebed, and they are installed in clusters in the back of coves with shallow sloping banks. These are common spawning areas for black bass, particularly largemouth bass, so these brush shelters would be located to increase spawning success (nest protection from wave action, satisfy bass preference for spawning near structure), as well as increase post-spawn survival of juvenile bass. Projects should be targeted in the elevation range between 775' to 875' to provide spawning benefits at a variety of ranges, and because during the summer and

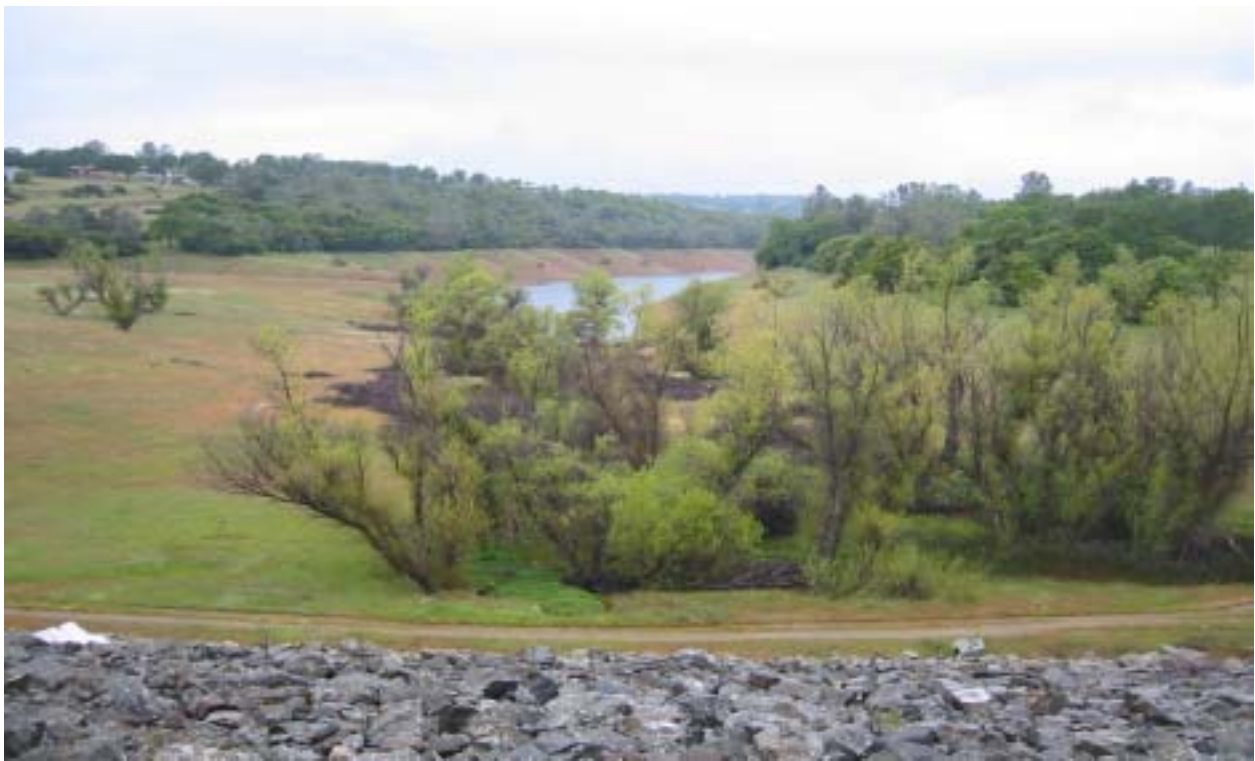
Figure 6. Willow Trees (Miners Ranch Area)

Native trees such as willow (*Salix spp.* and buttonbush (*Cephalanthus occidentalis*) would be planted in the fluctuation zone in the 850'–890' elevation range. These trees can survive periodic inundation as well as dry conditions found in the fluctuation zone in during the summer and fall, particularly if they survive the first 1 or 2 years and establish a deep root system. When successfully established, these trees provide large amounts of structural complexity over a long period of time and have the added benefit of enhancing the aesthetics of the reservoir fluctuation zone (Figure 6). As an example, many of the willows planted by DFG during the 1970's are now over 20' high and continue to grow, increasing the amount of cover provided. The 850' elevation is the lowest these trees should be planted because any planted below this elevation stand the possibility of being inundated year-round on a wet year due to the flood storage operations at the lake. This is why very few trees have ever survived long term at lake Oroville below this elevation, and even those trees are not found lower than about 840'.

- Cove near the Spillway Boat Ramp (tap into existing developed water system)
- Near Bidwell Campground (tap into existing and possible future developed water system)
- Near Loafer Creek Group Campground (tap into existing developed water system)
- Miners Ranch Area (divert existing creek)
- Parrish Cove (tap into existing developed water system from campground and/or Lime Saddle Boat Ramp, or pump from Miocene Canal)
- ~12 coves along 7 miles of the South Fk. Arm (pump water from OWID canal located immediately above the high water mark of Lake Oroville, as shown in Figure 6)
- Cove south of State Service Ramp, across from Loafer Creek Picnic Area
